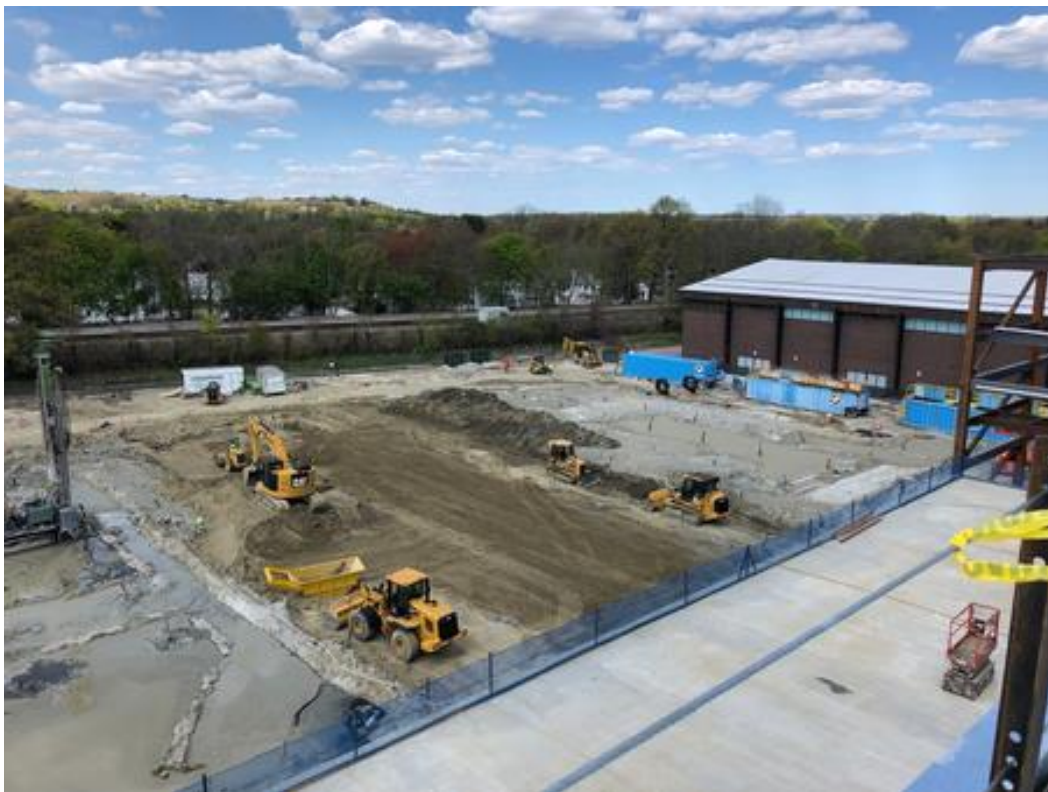
Photo 1 – Completion of Lateral Geothermal Piping Installation in field #1.

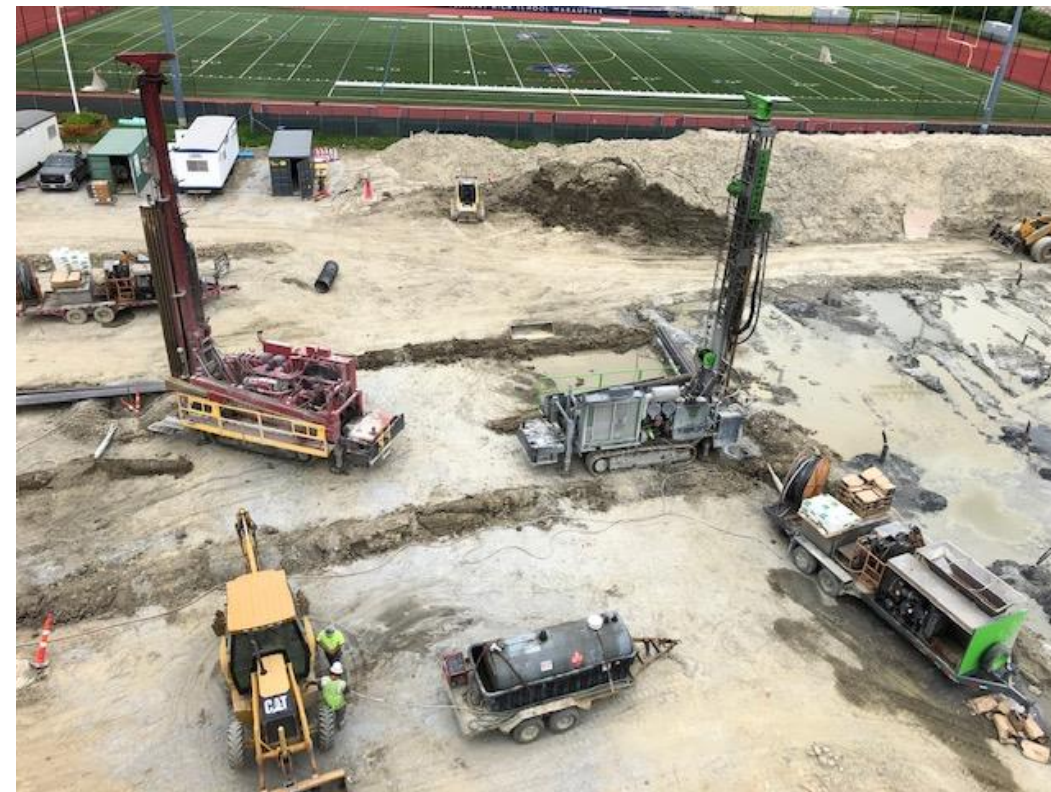
Photo 2 – Geothermal Well Drilling in Field #3.

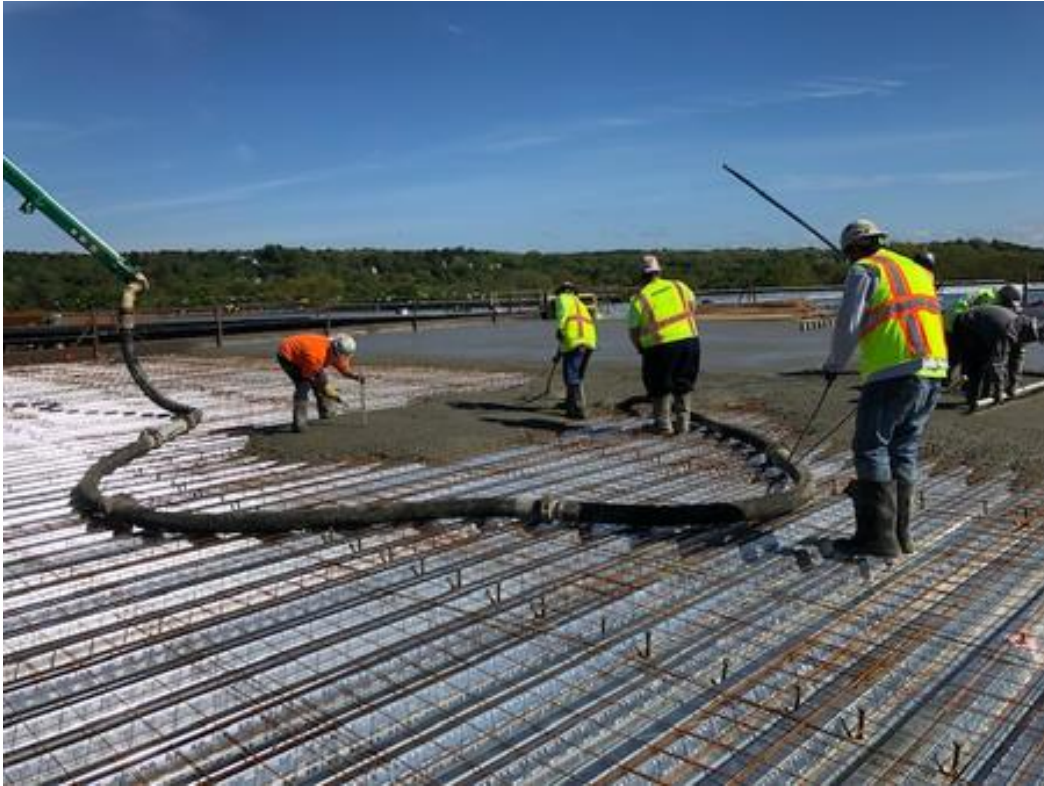
Photo 3 – Pouring Level 5 Building A Slab.

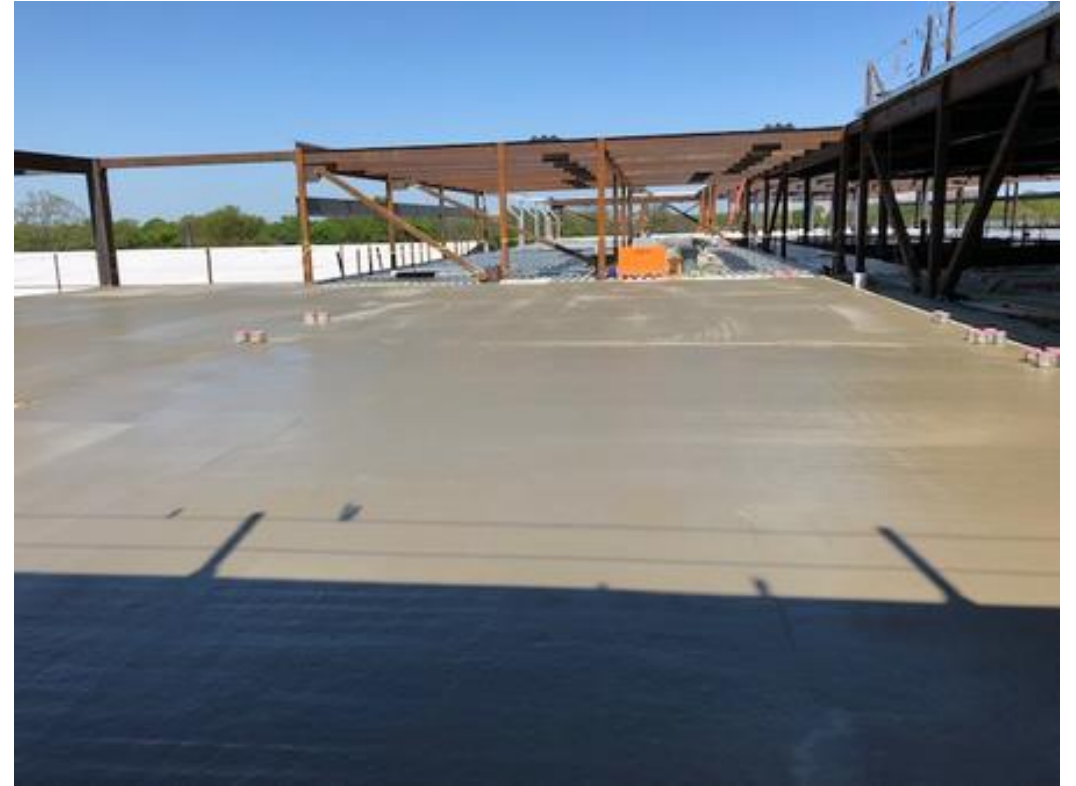
Photo 4 – Final Slab on Deck for Building B Roof.

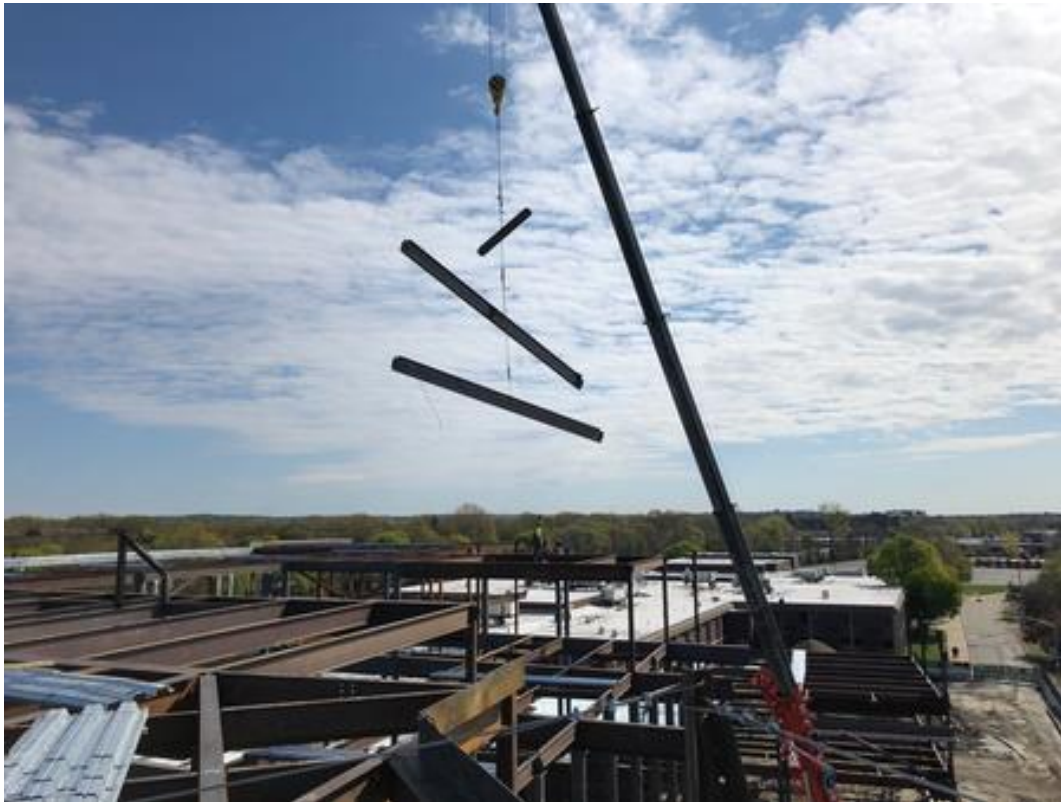
Photo 5 – Erecting Steel in Building C/D.

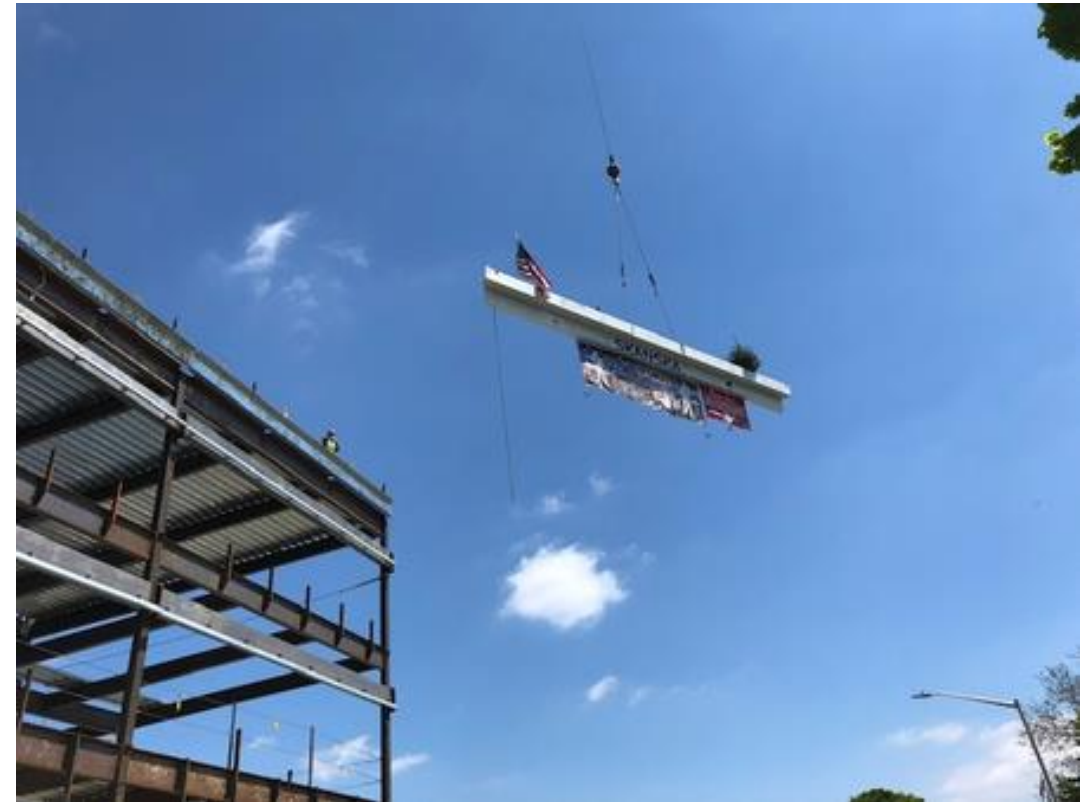
Photo 6 – Topping-off Steel Erection.

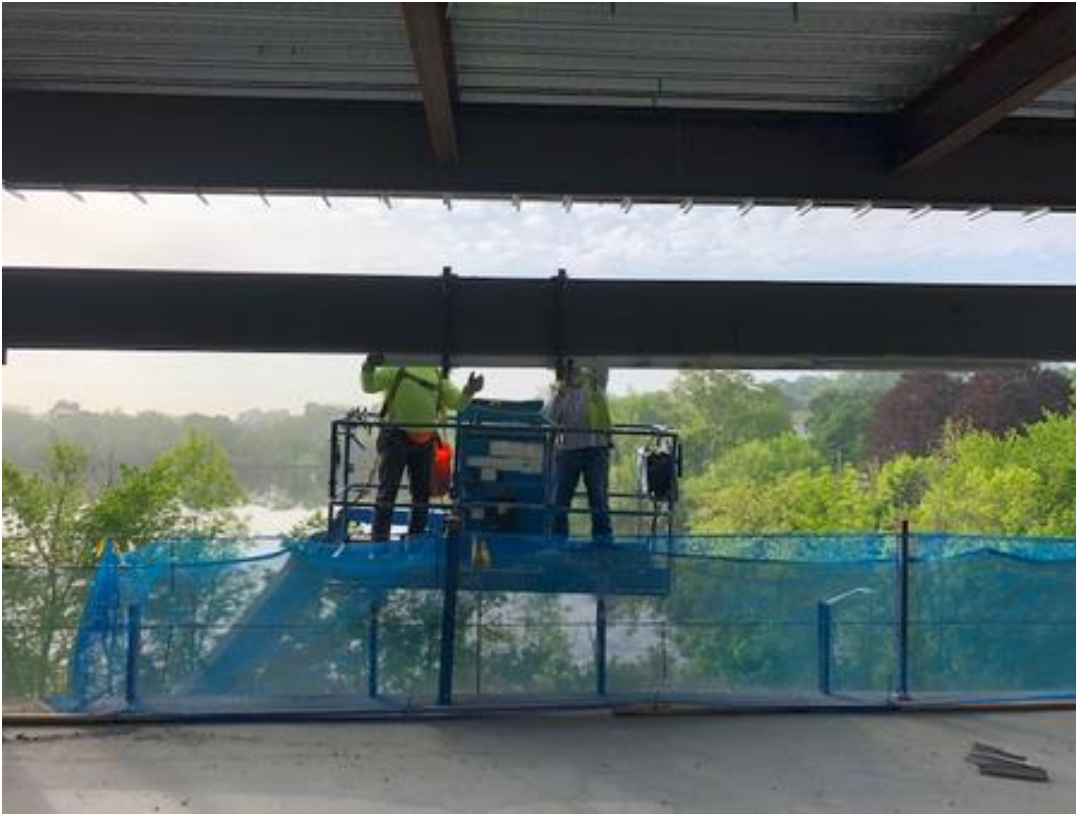
Photo 7 – Iron Workers Adjust Lintels in Building A.

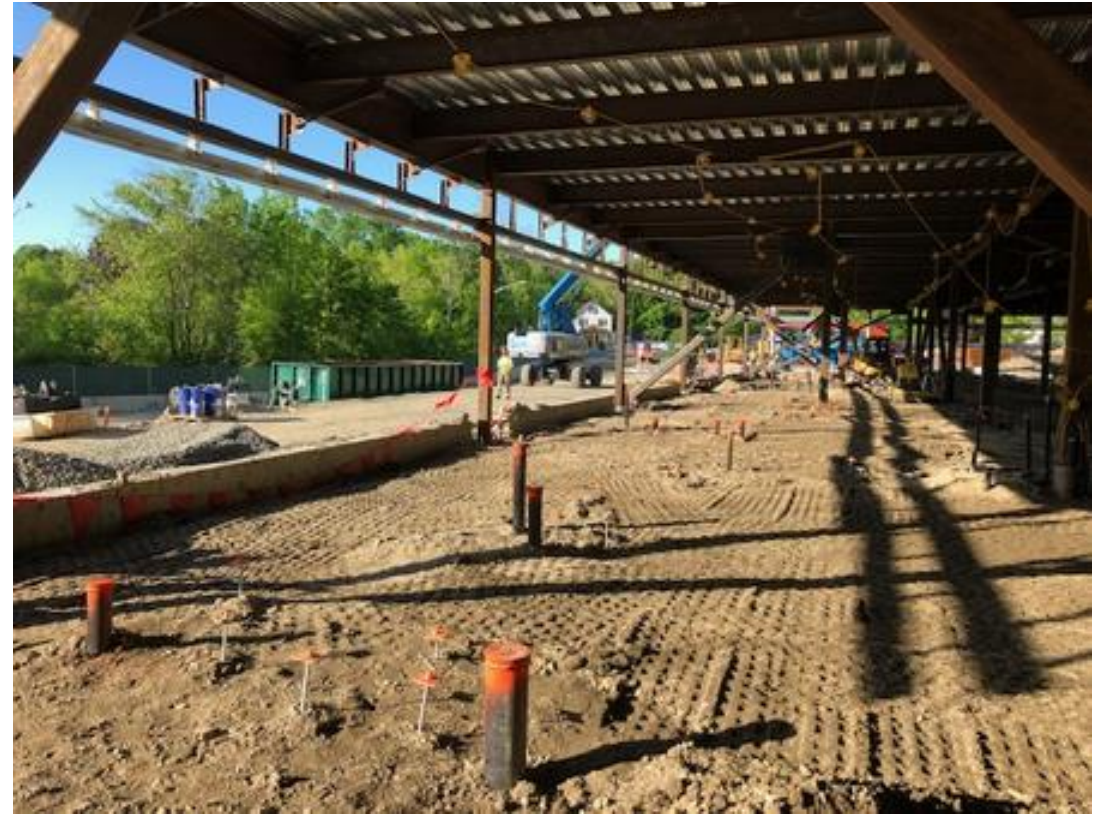
Photo 8 – Area A Underground Utilities Completed.

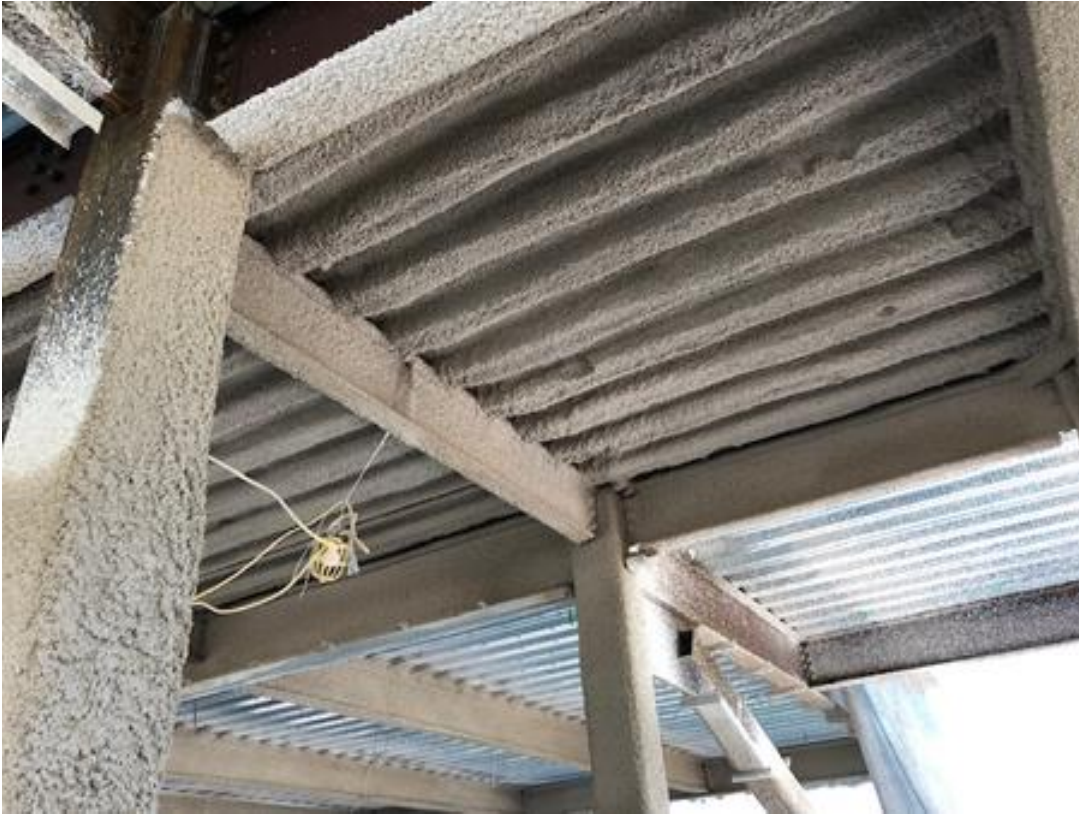
Photo 9 – Area A Spray Fireproofing on Structural Steel.

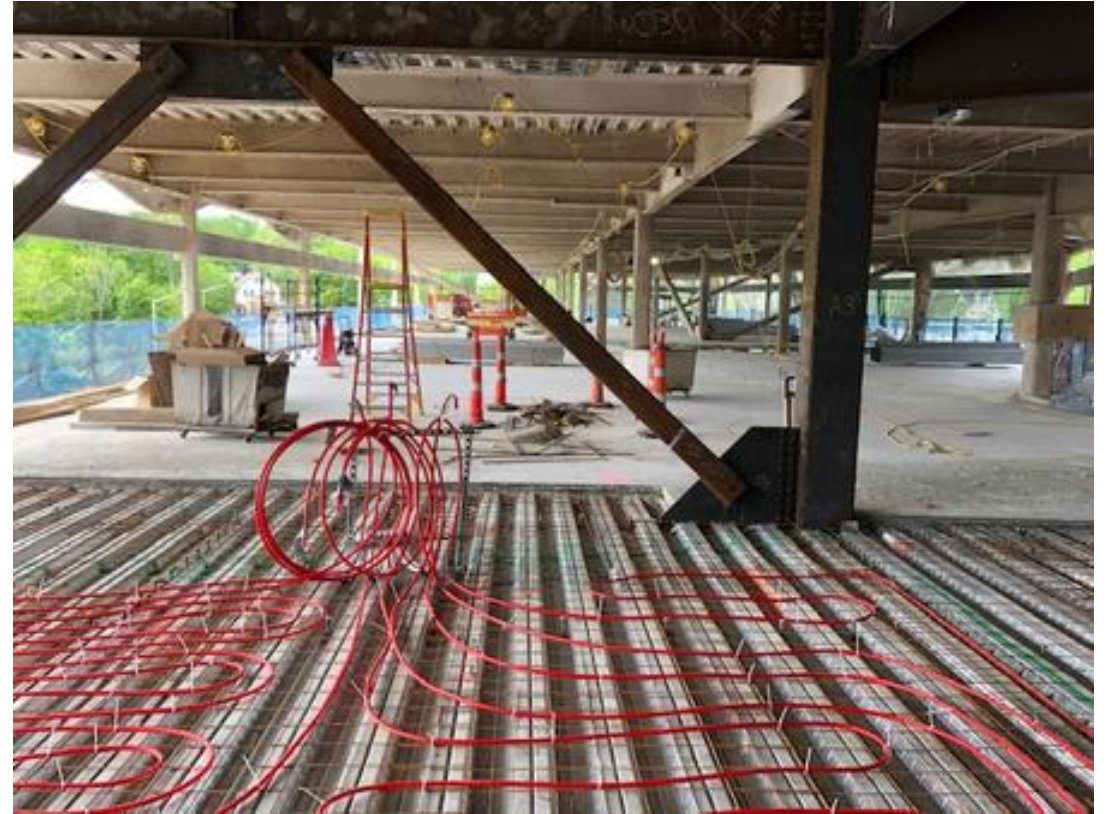
Photo 10 – Area A Radiant Piping and Spray Fireproofing.
