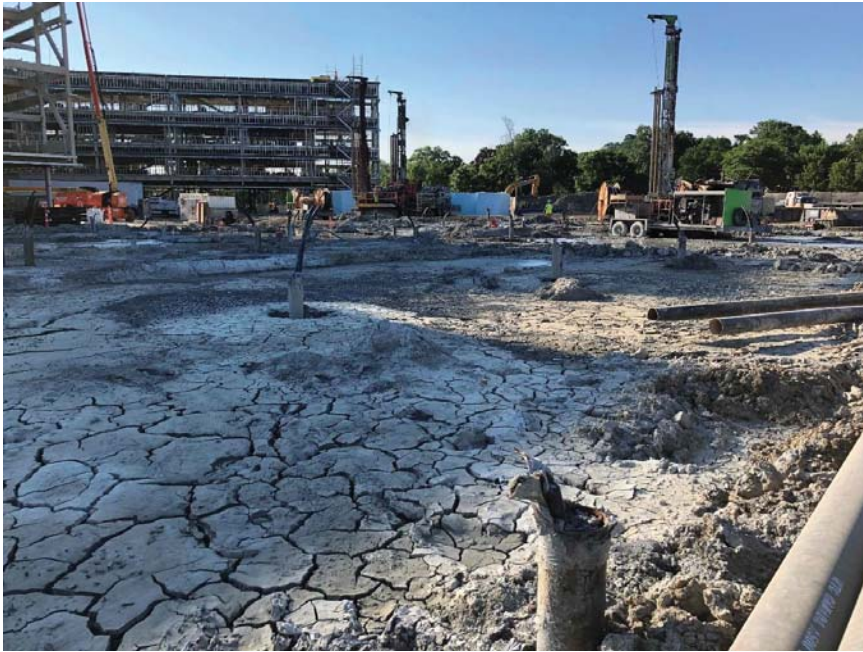
Photo 1 – Geothermal Well Drilling in Field #3.

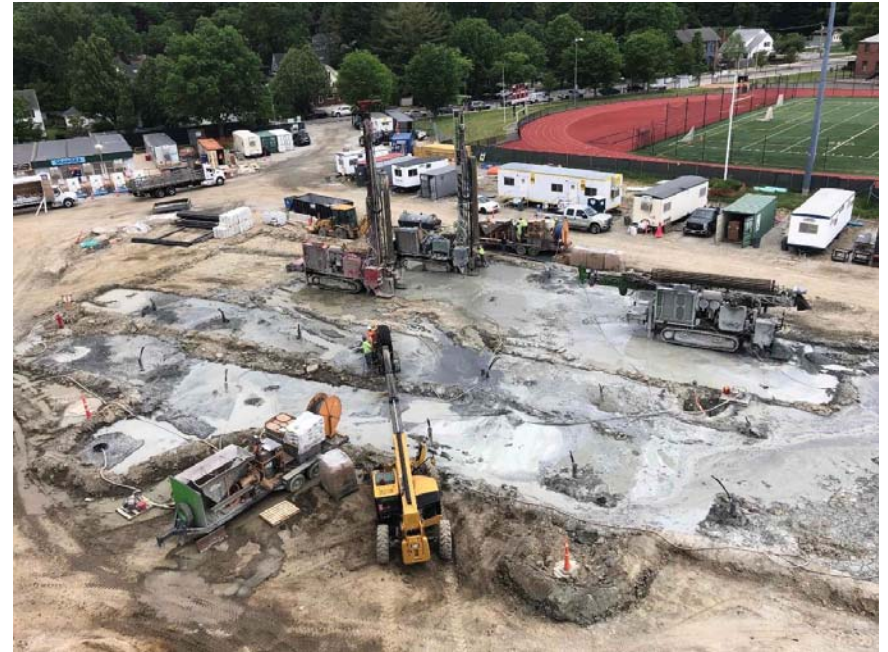
Photo 2 – Geothermal Well Drilling in Field #3.

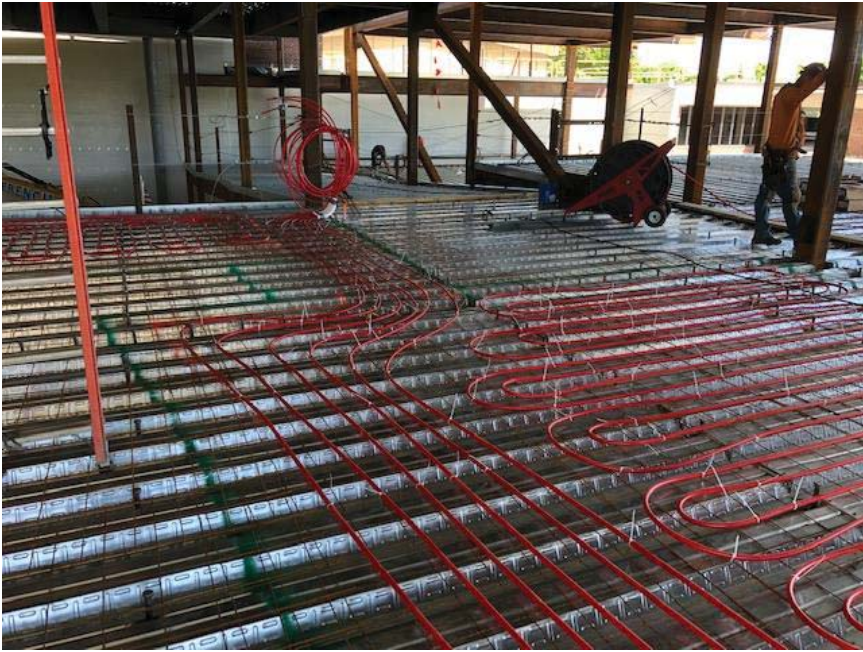
Photo 3 – Area C Radiant Piping Prior to Slab on Deck Placement.

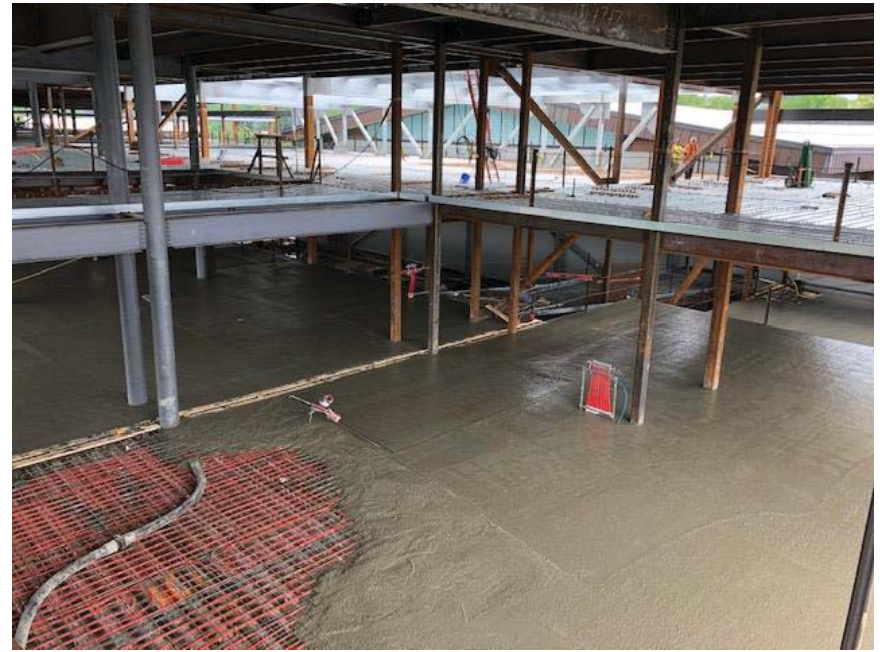
Photo 4 –Slab on Deck Placement for Building C/D Level 2.

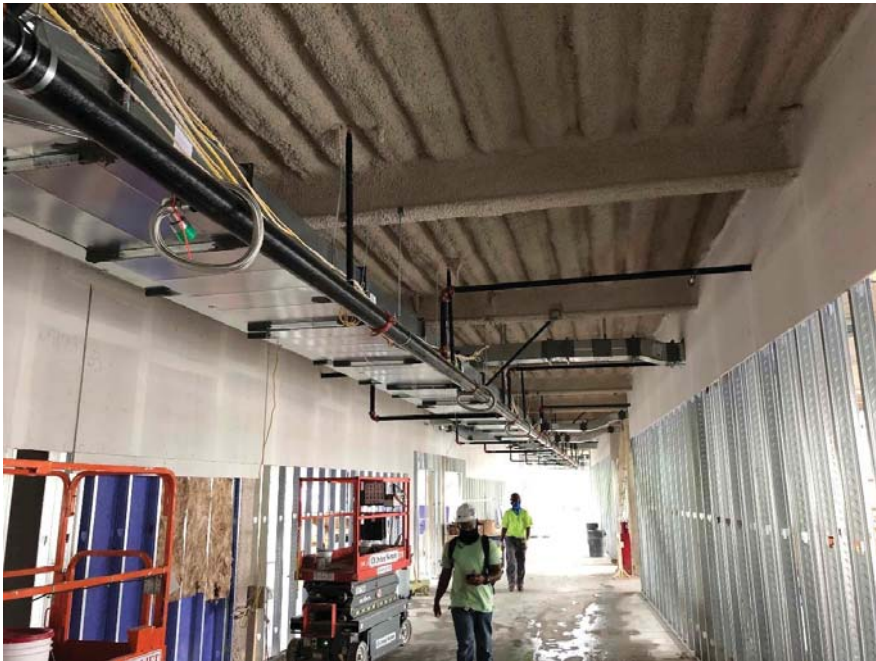
Photo 5 – Building A Corridor with MEP components, wall framing, and some sheathing installed.

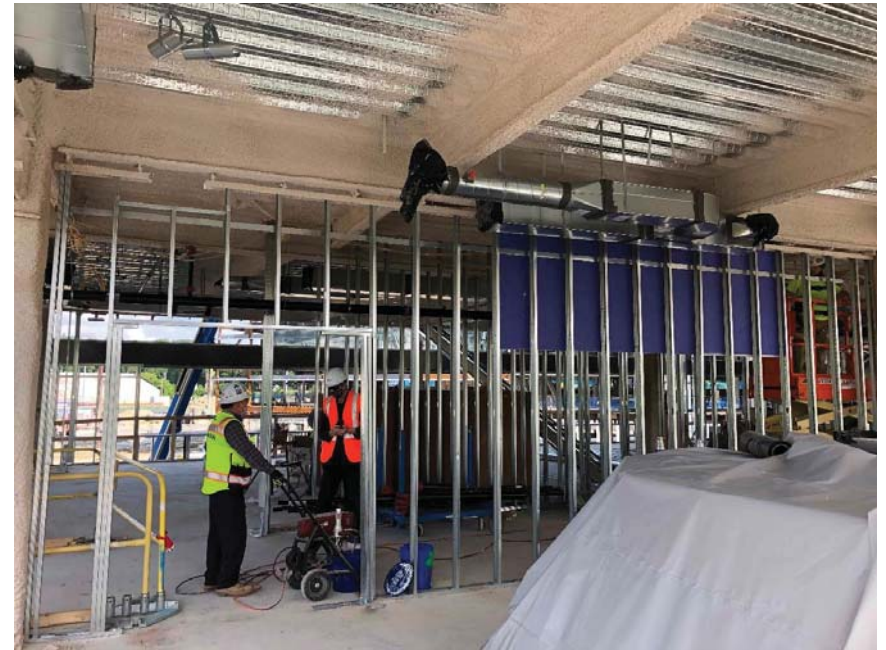
Photo 6 – 1st-in-Place Inspection of Sheathing with Gary Hewitt (SKA) and Jeff Brussel (PW).

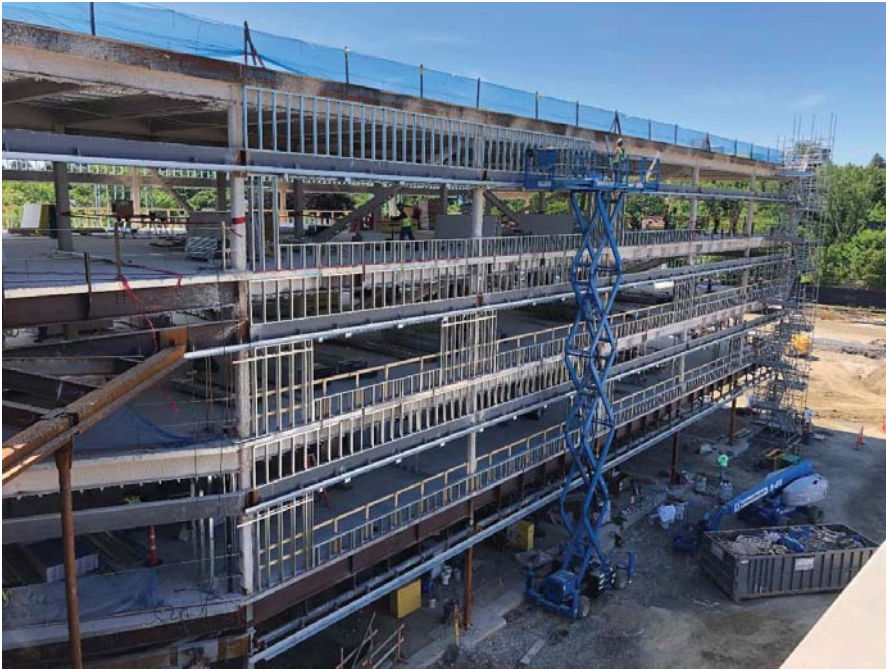
Photo 7 – Building A West Elevation Being Framed.

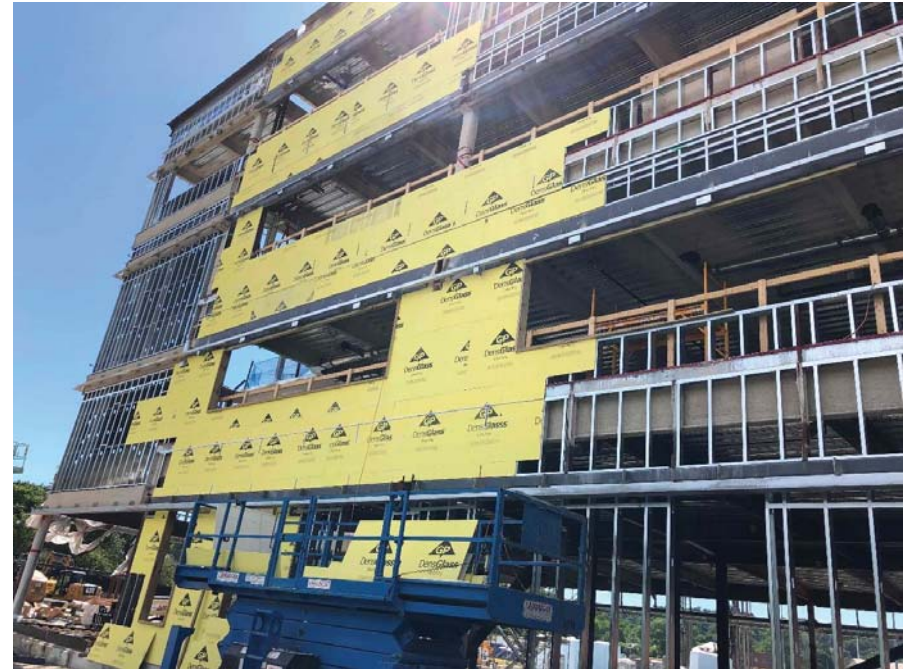
Photo 8 – Building A East Elevation External Sheathing.

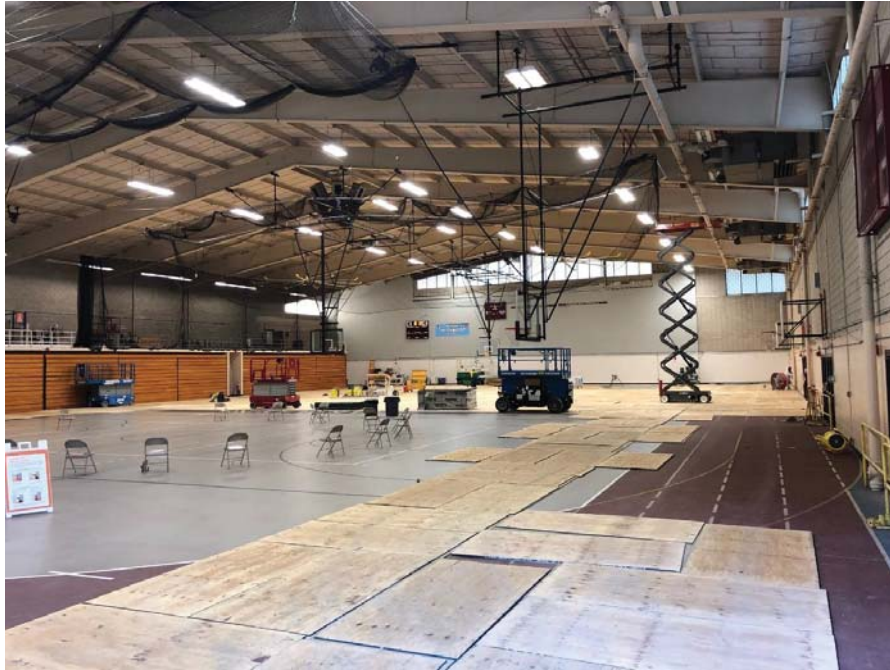
Photo 9 – Floor Protected Field House with Chairs Located to Accommodate Socially Distanced Meetings.

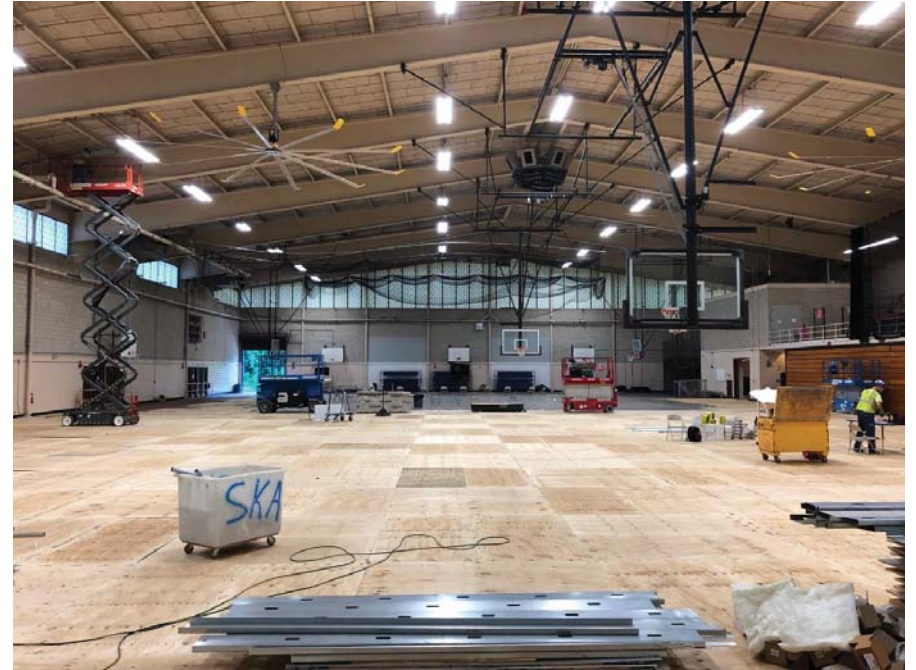
Photo 10 – Griffin Electric Working in Field House.
