Progress Photos

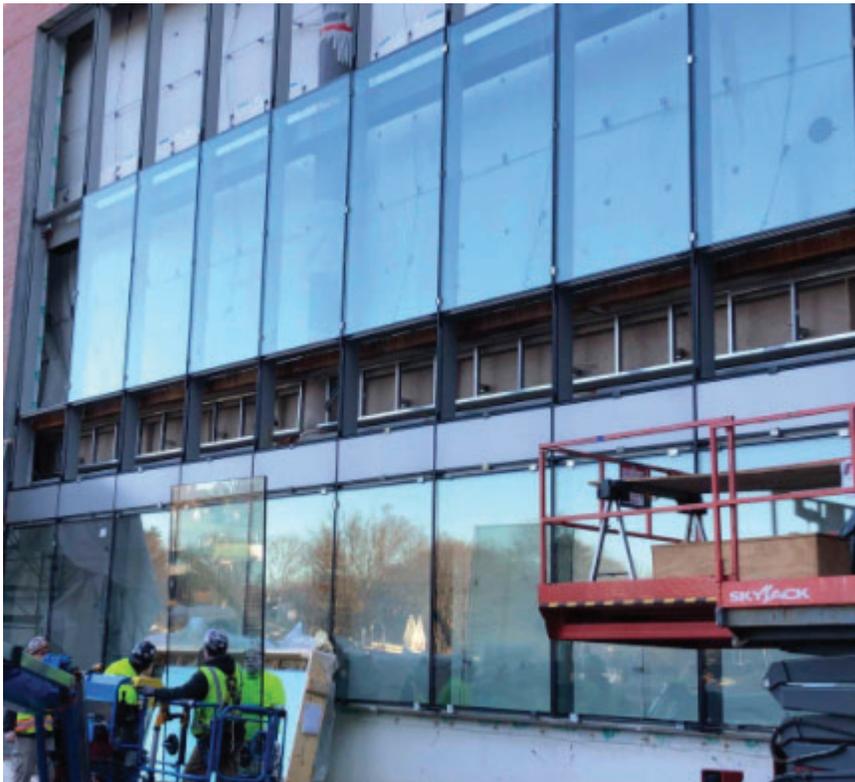
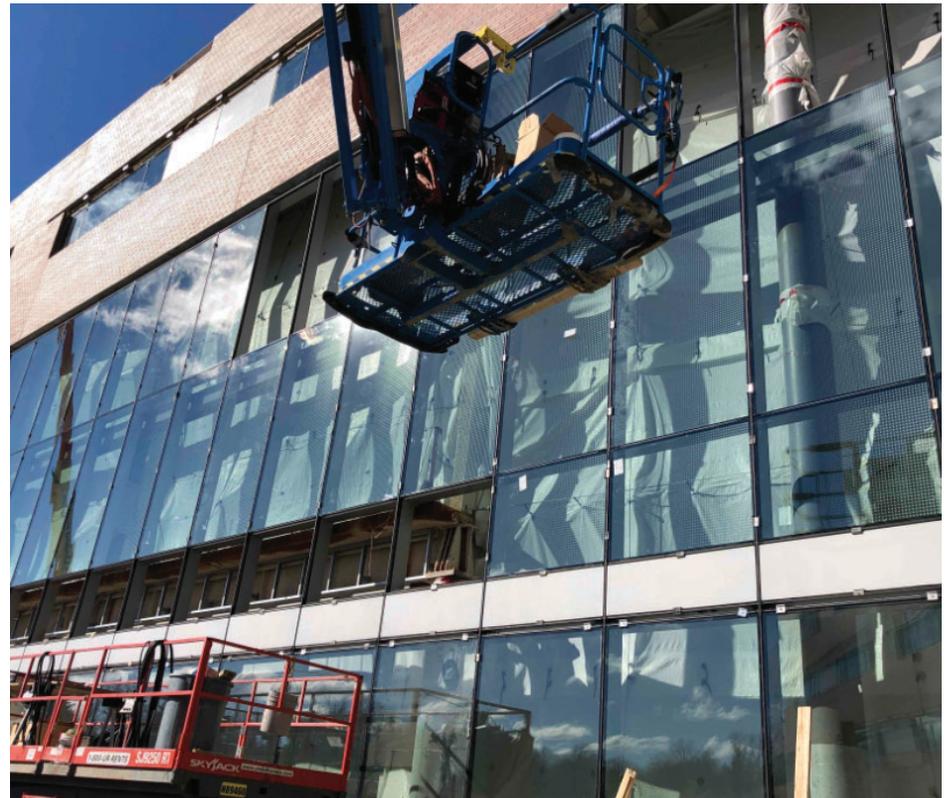
- Area B, South façade – multi-story curtain wall

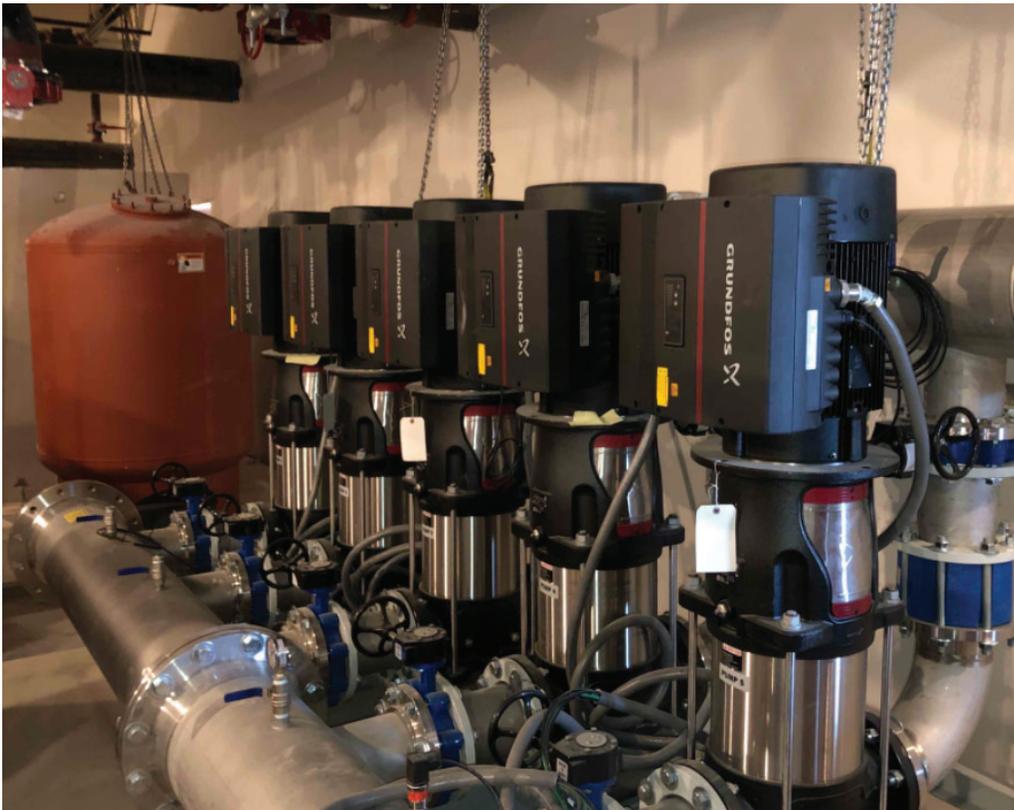
- Area C, level 1 – main mechanical room equipment

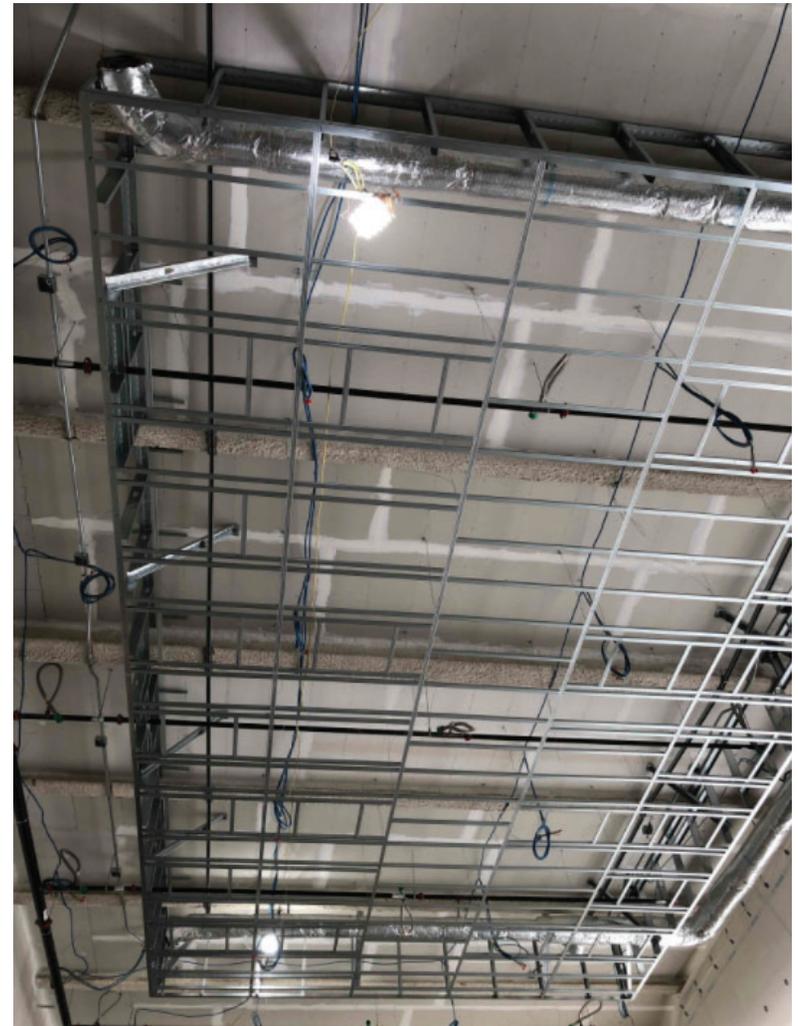
- Area B, level 2 – sound isolating GWB ceiling soffit

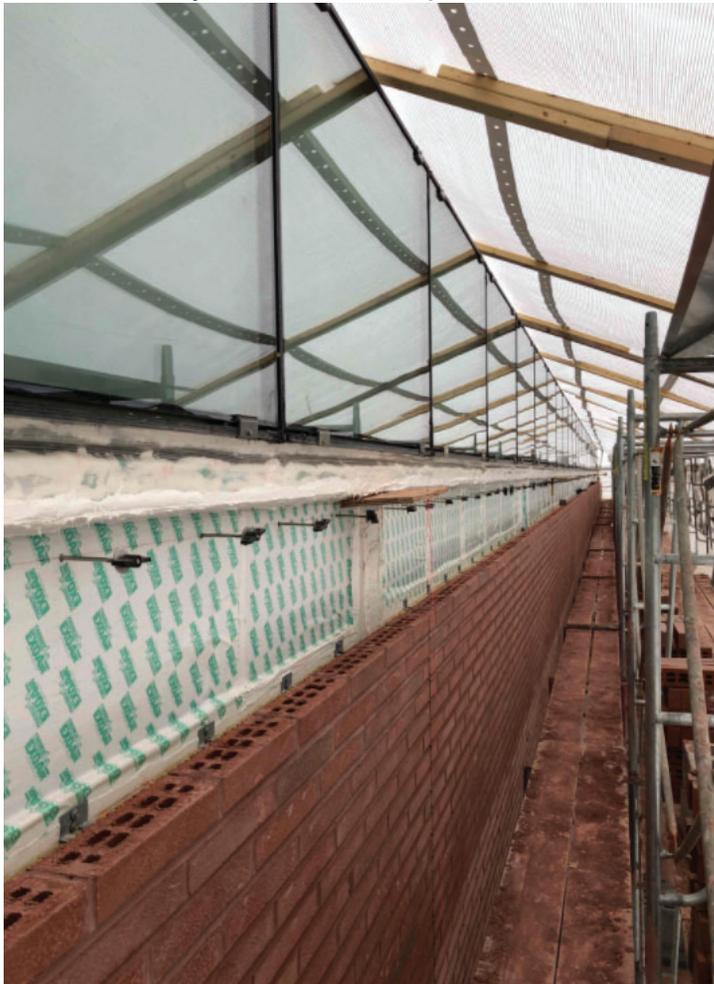
- Area B, North façade – clearstory windows and masonry under weather protection

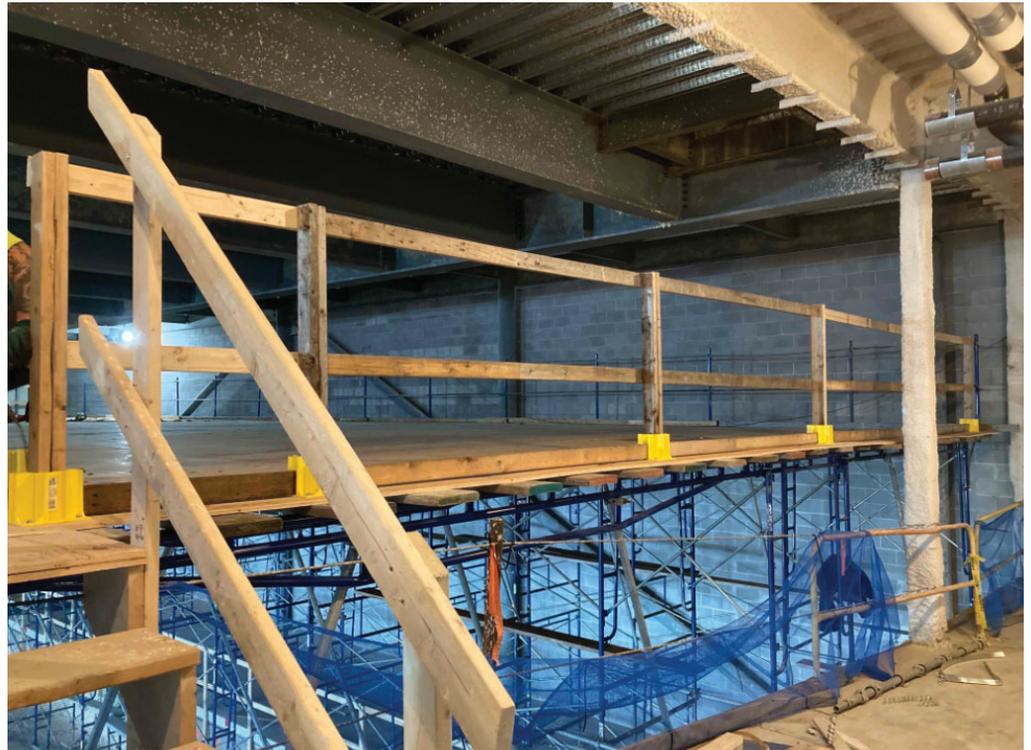
Area C, level 2 – scaffold staging for pool ceiling

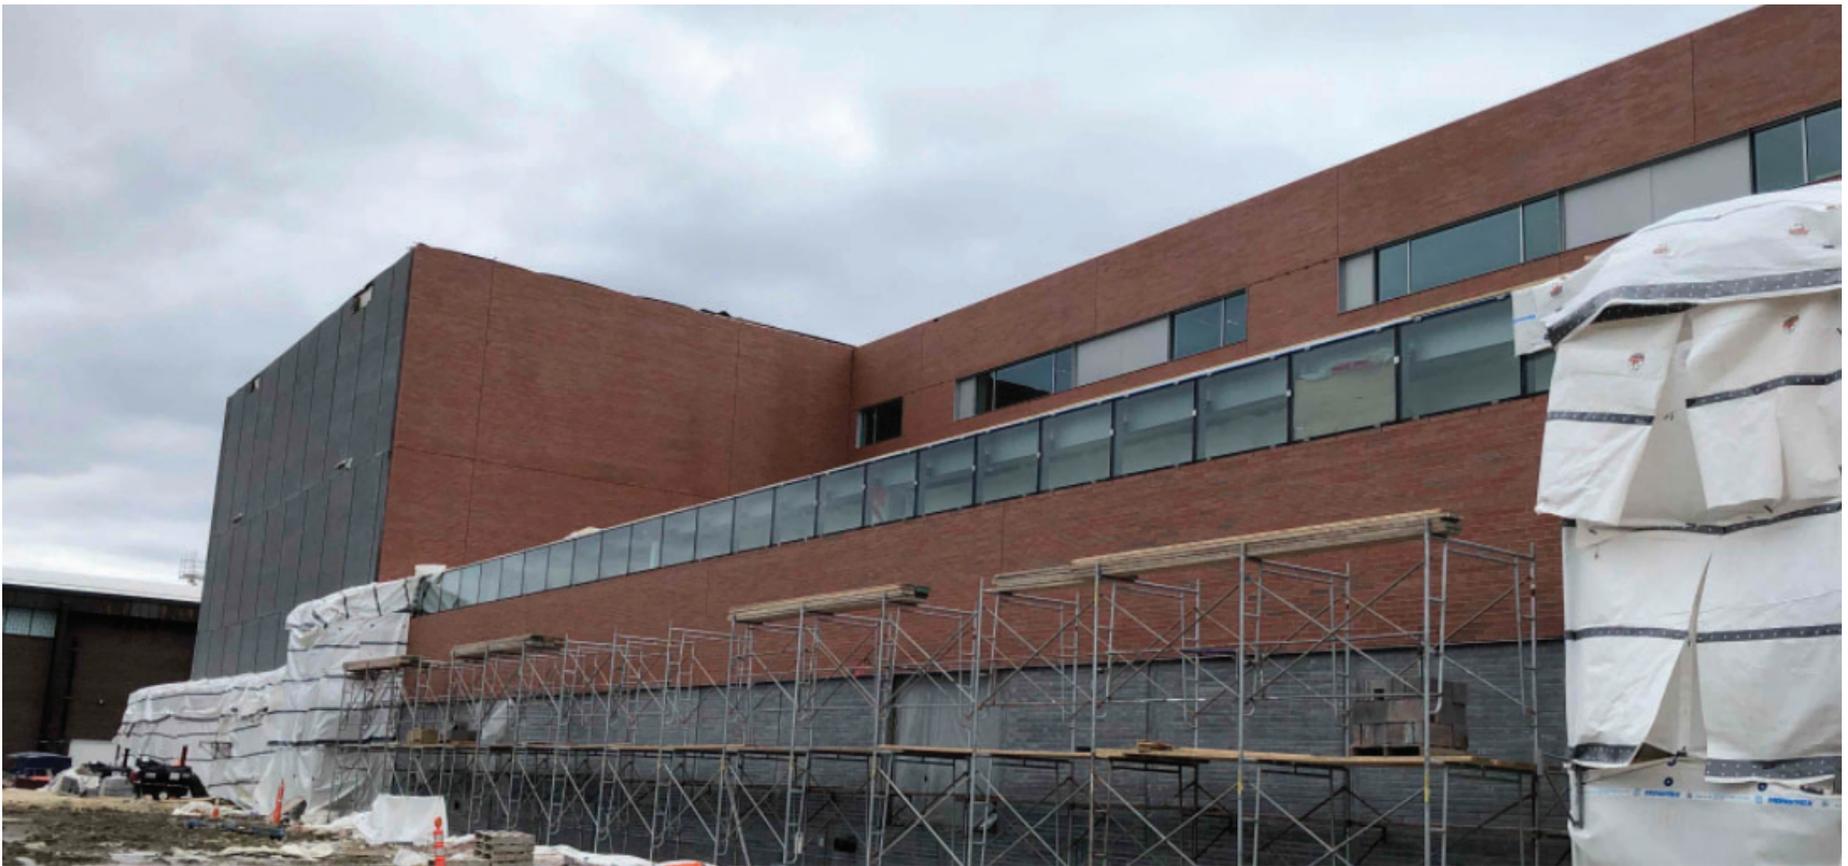
- Area B, North façade – glazing, metal panels and masonry

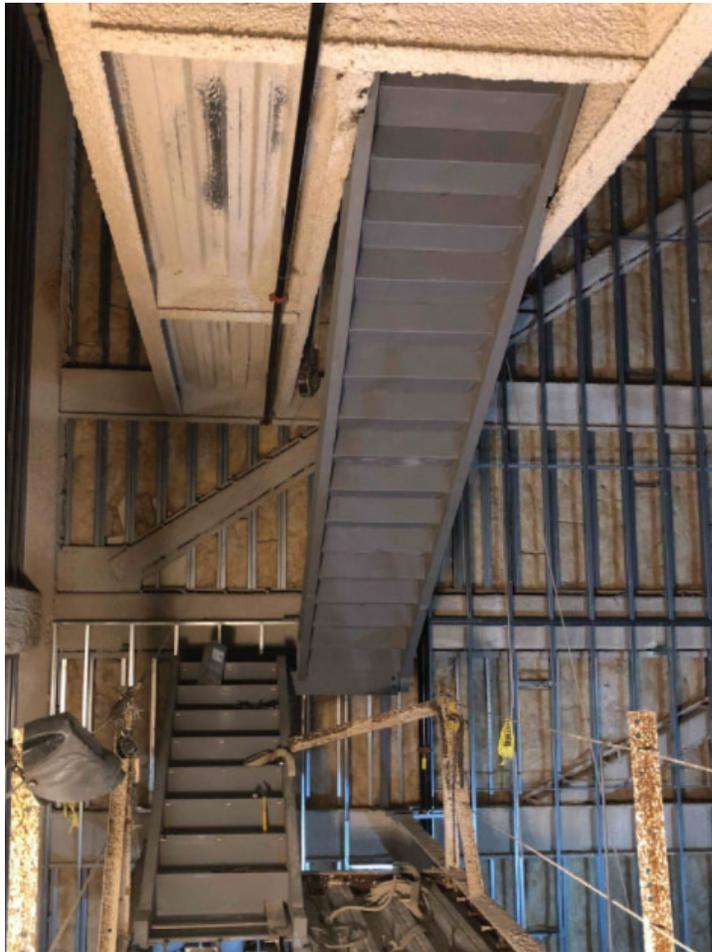
- Area B, level 3 – Stair #13 steel at auditorium stage

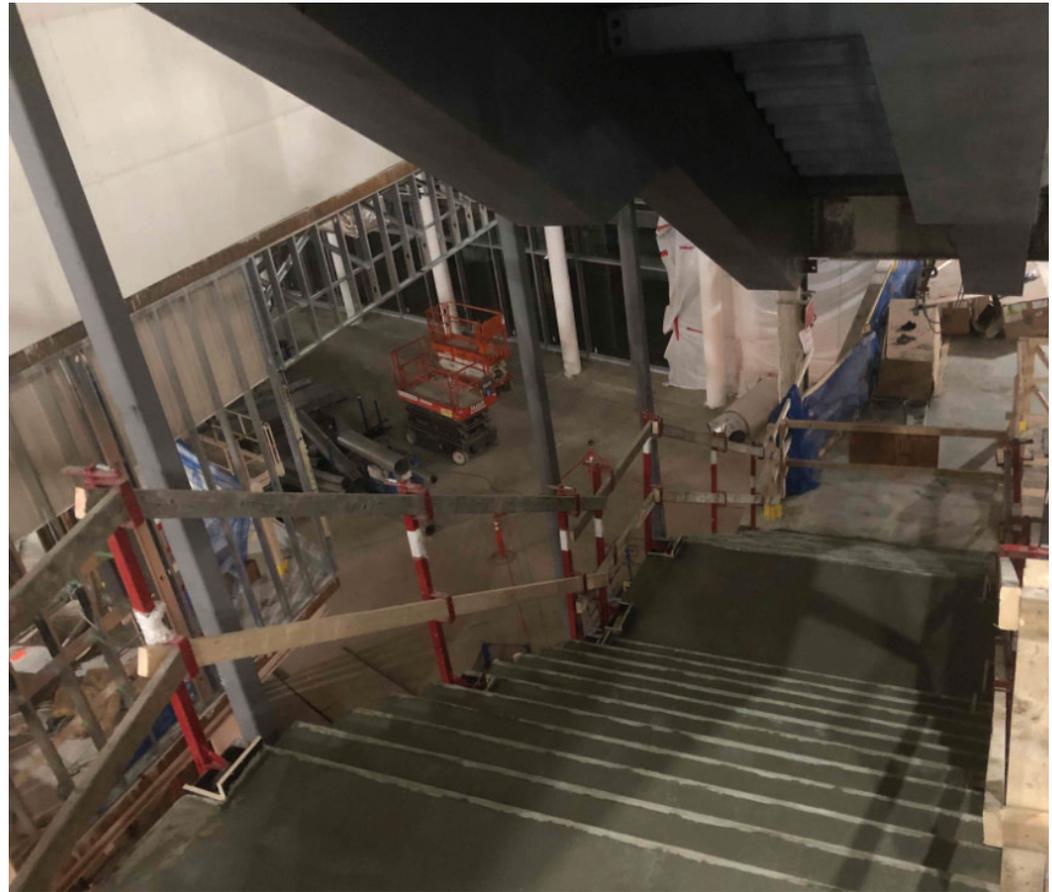
- Area C, level 3 – Stair #3 steel and concrete

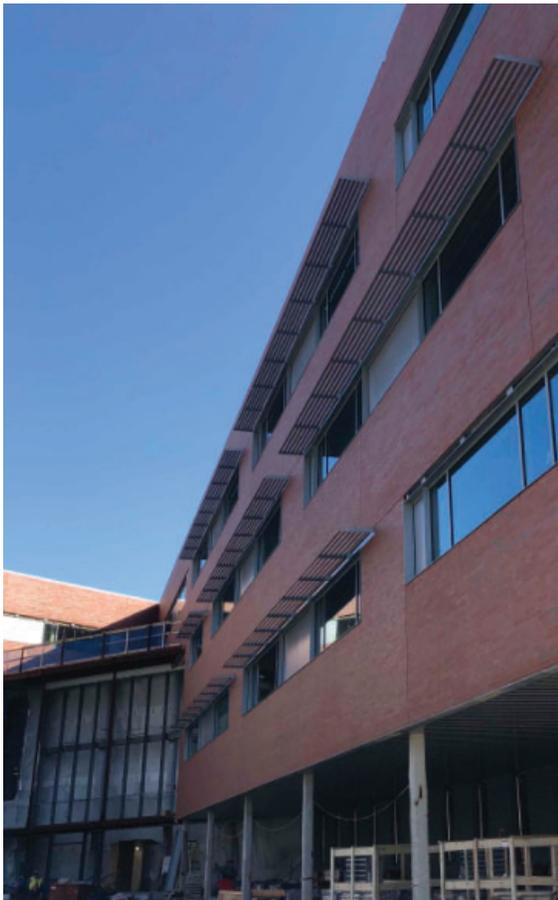
- Area A, West façade – glass, metal panels and sunshades

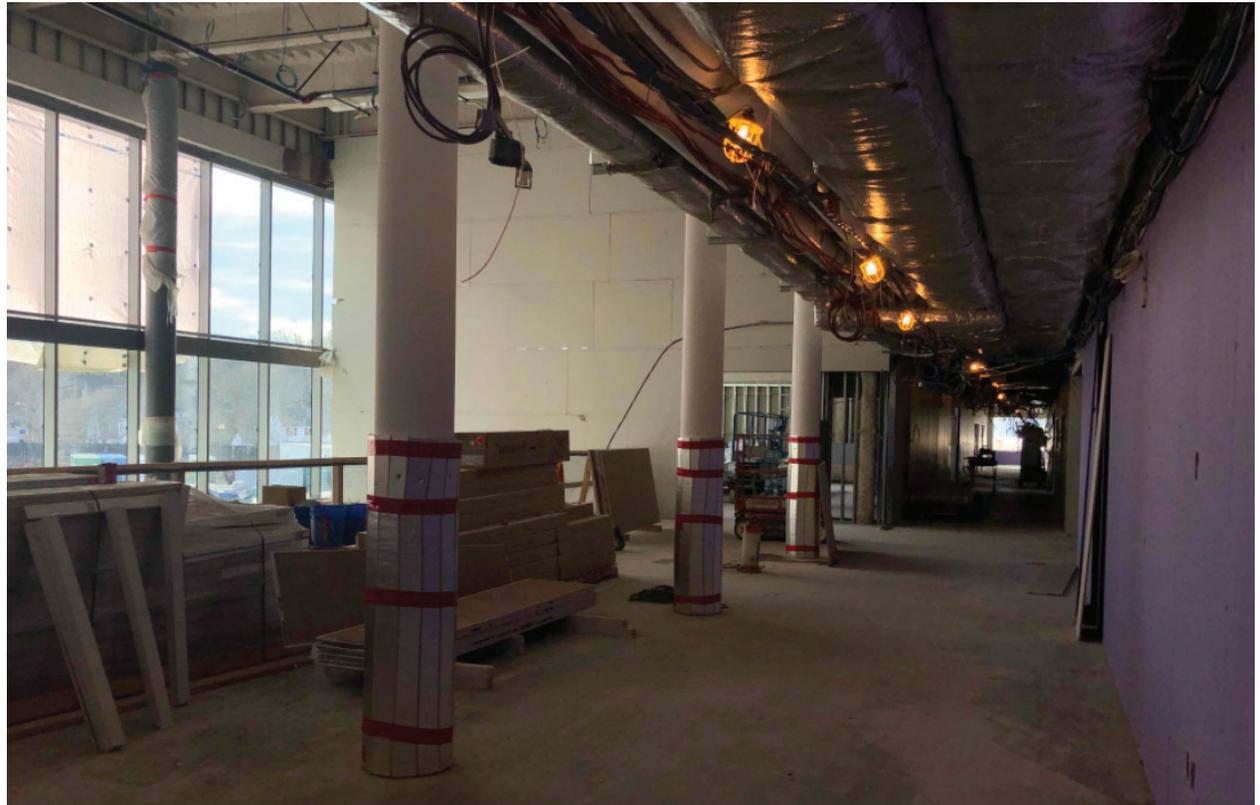
- Area B, level 2 – intumescent paint for structural columns, drywall, and multi-story curtain wall
